Independent Home Inspection LLC

Building Inspection Report

20 River View, Hudson Valley, NY 12345
Inspection prepared for: John Jones
Date of Inspection: 5/24/2018 Time: 1 PM
Age of Home: 1835 Size: 2549
Weather: 50s

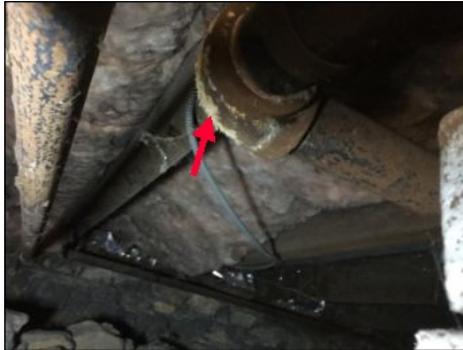
Observations: There is some asbestos like pipe insulation remnants noted, recommend removal by asbestos abatement contractor to ensure indoor air quality.

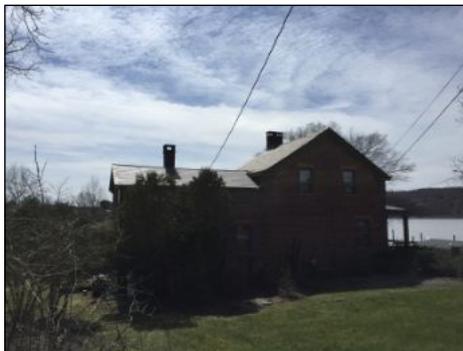
Observations: The general topography directs water towards the structure, not necessarily surface water only but subterranean water as well. This area tends to be prone to moisture intrusion and should be monitored.

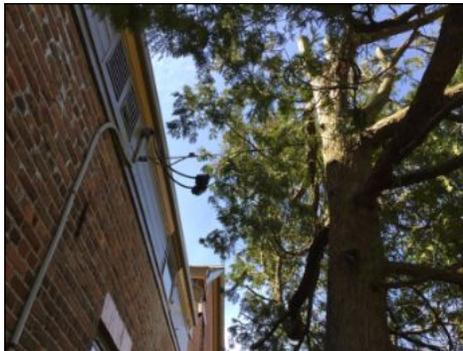
Observations: There are trees noted close to the structure which have the potential of causing damage to the building, recommend consulting arborist for further evaluation, monitoring, trimming, and or removal.

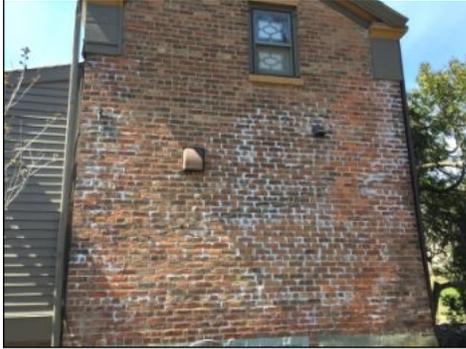
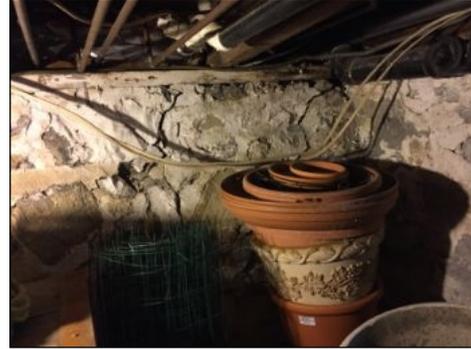
Observations: There is bulging wall covering and mortar joint sealant repairs which needs further evaluation, monitoring, and or repair. Foundation cracking and cistern trench is below.

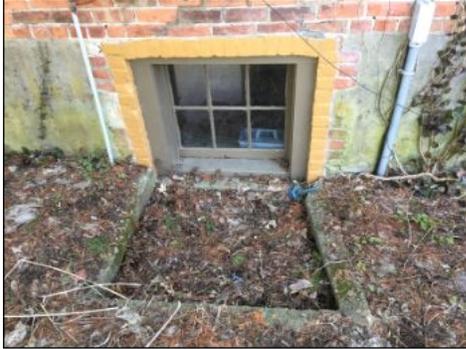
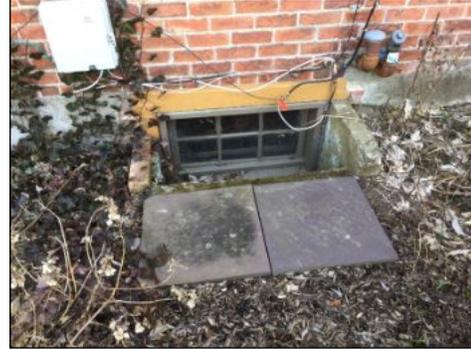
Observations: The basement window wells are debris filled and lack proper ground clearance which should be cleaned, improved, and or replaced to ensure adequate drainage.

Moisture intrusion appears to be occurring.

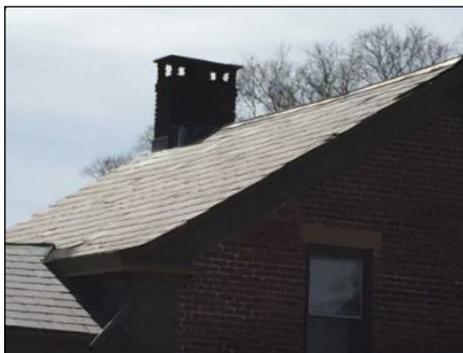
Observations: Roof shingles have been nonprofessionally installed over wood roof shingles creating conducive conditions to leakage, cracked, and loose shingles.

Observations: There are loose, cracked, chipped, and missing shingles on older section of roof which need repair and or replacement by slate roof specialist to ensure water tightness.
There loose shingle fasteners which need repair to ensure integrity.

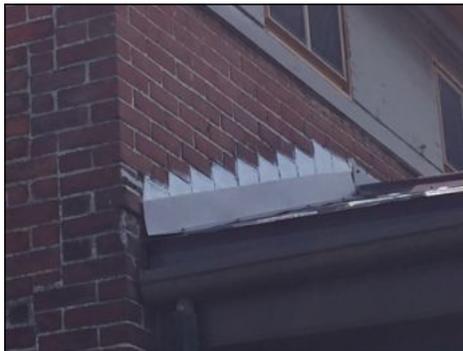
Observations: Juncture lacks proper counter flashing which needs further evaluation and repair to ensure water tightness.

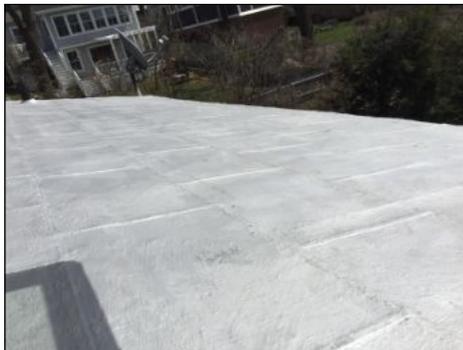
Observations: Roof is old and appears original to the building which has multiple layers of sealer applied. Roof should not be expected to last a long period of time. Recommend updating to ensure water tightness.

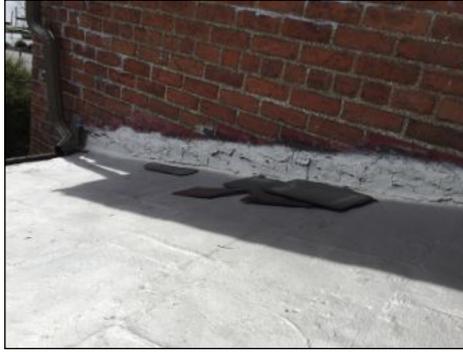
Observations: Area lacks proper flashing and needs repair to ensure water tightness.
Moisture intrusion appears to have occurred which is evident from peeling interior finish.

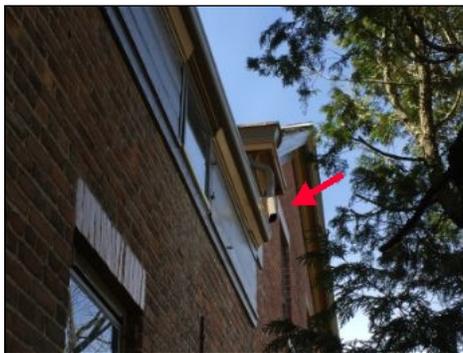
Observations: Downspout is disconnected and needs repair.

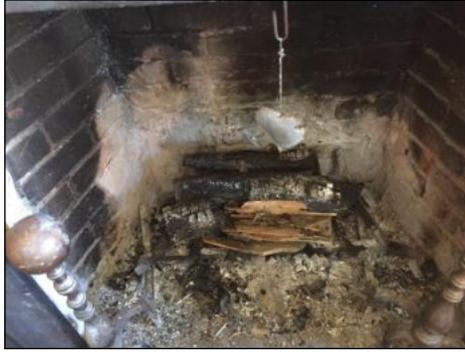
Observations: Firebox is deteriorated and needs further evaluation and repair by fireplace specialist before use.

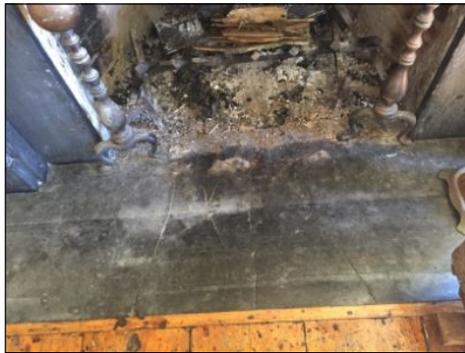
Observations: The hearth extension is cracked which needs repair.

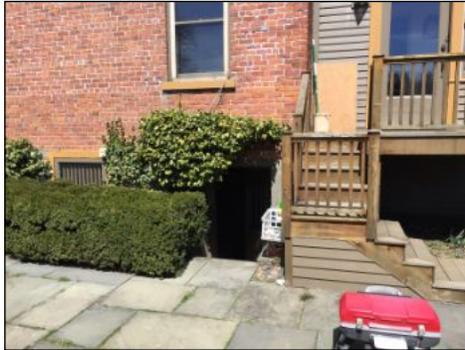
Observations: Skirting has wood to ground contact which is conducive to rot and wood destroying insects that should have ground clearance created. Skirting is rotted in prone areas which needs repair.

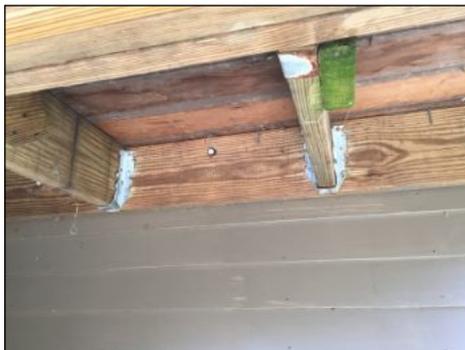
Observations: The deck will need a finish applied in the near future to maintain integrity.

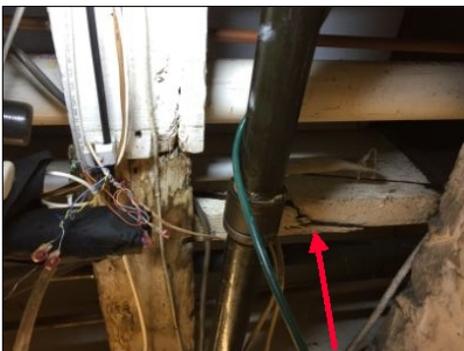
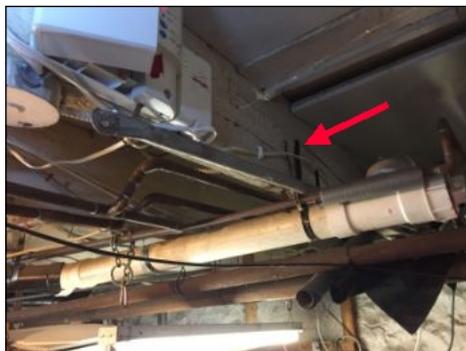
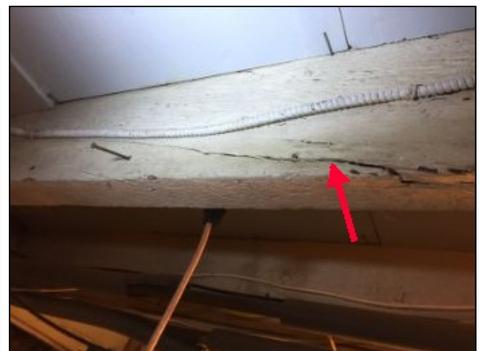
Location: Interior wall front to back
Observations: Floor has slopping towards interior wall which should be further evaluated, additional support added, and or repaired by structural engineer and qualified contractor to ensure adequate support.

Location: Basement
Observations: There are cracked floor joist below slopping walls and floor which needs further evaluation, repair, and or additional support by carpenter and structural engineer to ensure integrity.

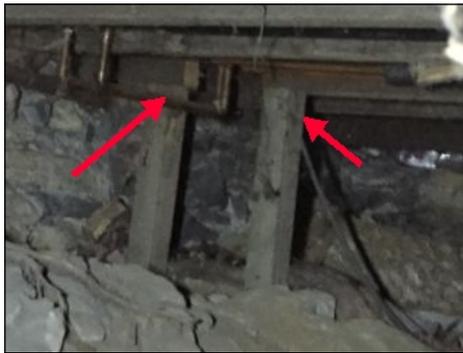
Observations: Floor joist has been cut and temporary support has been installed which needs review and repair by structural engineer and carpenter to ensure proper support of the floor framing.

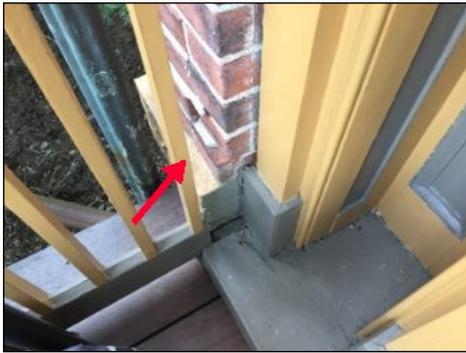
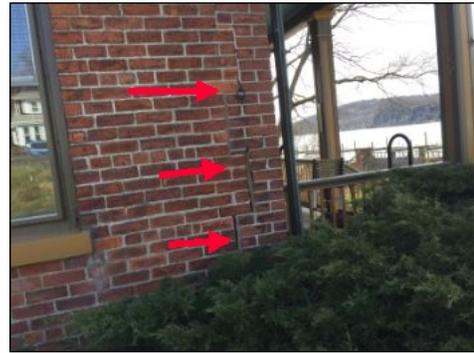
Observations: Vertical cracking, stair stepped cracking, and displacement are present which needs evaluation, repair, additional support, and or monitoring by structural engineer and foundation specialist to ensure integrity.

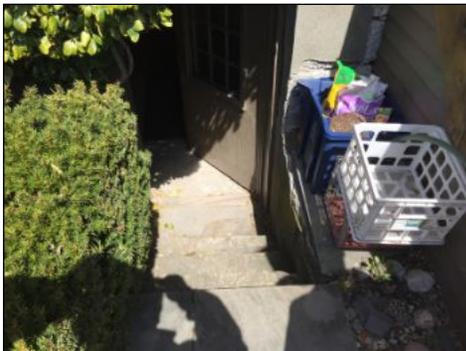
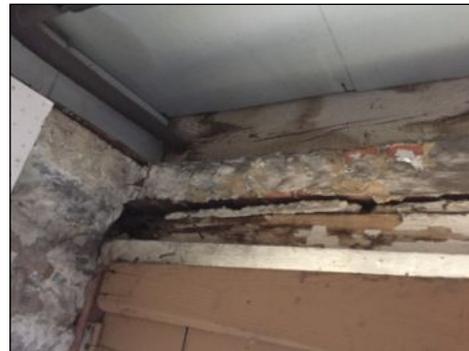
Observations: Wood exterior access is not weather sealed, allowing moisture intrusion, and has rot and deterioration which needs replacement.

Wood header above door is rotted and needs repair.

Area lacks floor drain which should be added to prevent ponding water. Moisture intrusion appears to occur.

Stairway lacks a handrail?guardrail which needs installation.

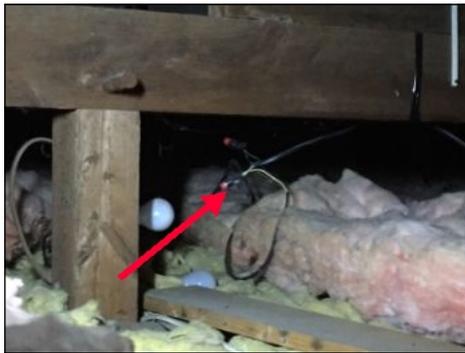
Observations: There are electrical connections improperly made out of a junction box which needs review and repair by electrician.

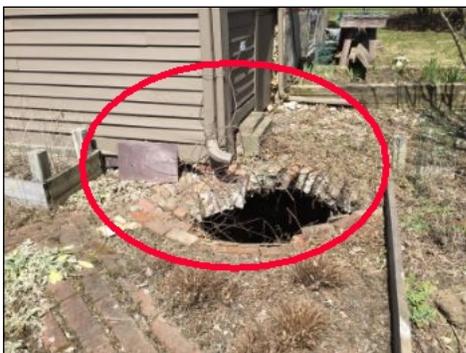
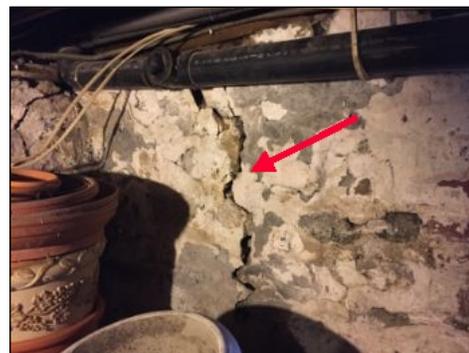
Observations: Abandon collapsing open cistern is present right side back of the building which is a safety hazard which needs major repair, filled, or removed by structural engineer and qualified contractor to ensure safety and integrity.

Cistern trenching is present back of the building under and or adjacent to the back foundation wall which appears to be resulting in settlement and or cracking of the foundation and walls which needs complete review and repair by structural engineer and qualified contractor.

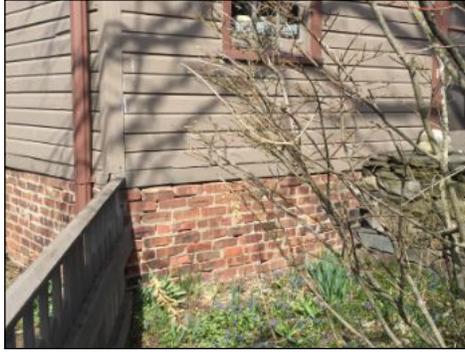
Observations: Wall covering, ceiling covering, and flooring limits visual access.
Brick foundation stem walls have deteriorated mortar joints and loose brick which need repair.

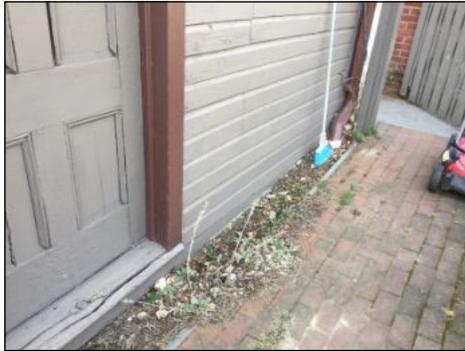
Areas of the grading at the left side are equal to and over the wall covering which is conducive to rot and wood destroying insects. Recommend grading area to establish a clearance to wall covering, current standards is 6" minimum ground clearance to wall covering.

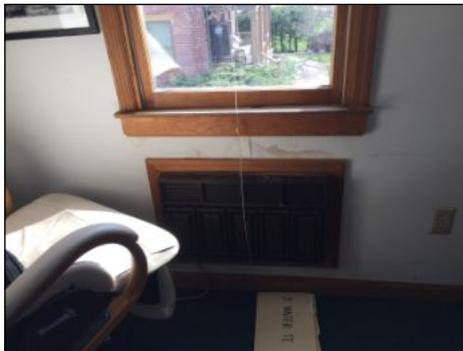
Wall unit air conditioner wall penetration appears to be allowing moisture intrusion which needs repair.
