# Independent Home Inspection LLC

## Inspection Report

123 Main Street, Anytown, NY 12540

Date of Inspection: 1/1/2025 Time: 12:30 PM

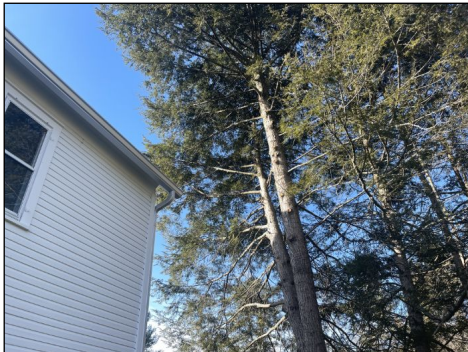
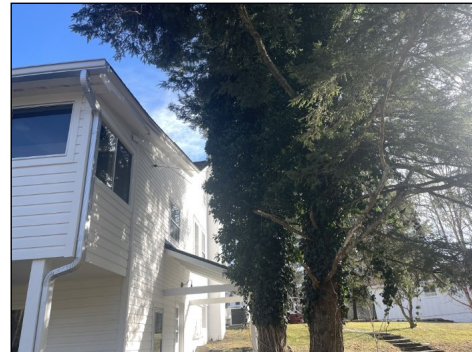
There are trees present in the yard which require periodic maintenance to ensure safety, recommend consulting arborist for further evaluation, trimming, and/or monitoring.

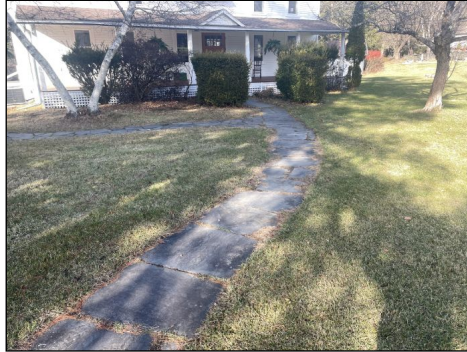
*Observations:* The surface is in usable condition with some cracking, settlement, and weathering.

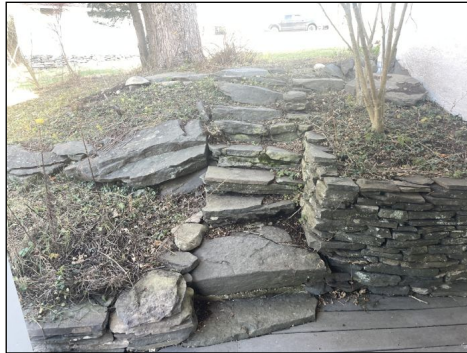
Natural stone stairway has some settlement and displacement which needs adjustment or repair to ensure safe usage.

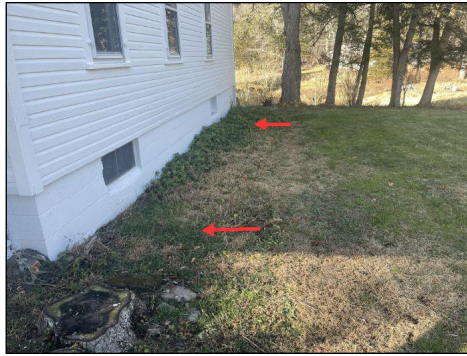
Areas of grading next to the foundation lack proper slope away from the building and has settlement in areas creating conducive conditions to moisture intrusion, recommend repairing grading to direct water away from the building. Typically, a minimum of one inch per foot pitch away from the building for at least six feet away from the building should be provided.

Moisture intrusion is occurring in this area.

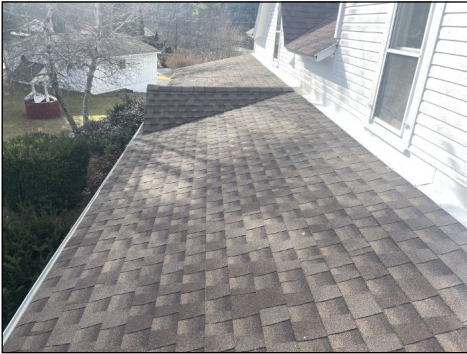
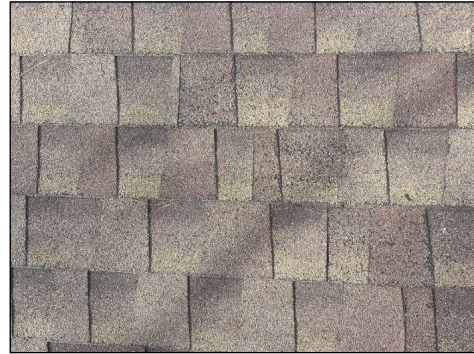
*Observations:* General condition of the roof covering is functioning but older with signs of weathering and aging appropriate to approximate age of roof.

The roof surface has some loss of aggregate and brittleness noted which indicates the surface is wearing and aging and will need replacing in the near future in accordance with its designed lifespan.

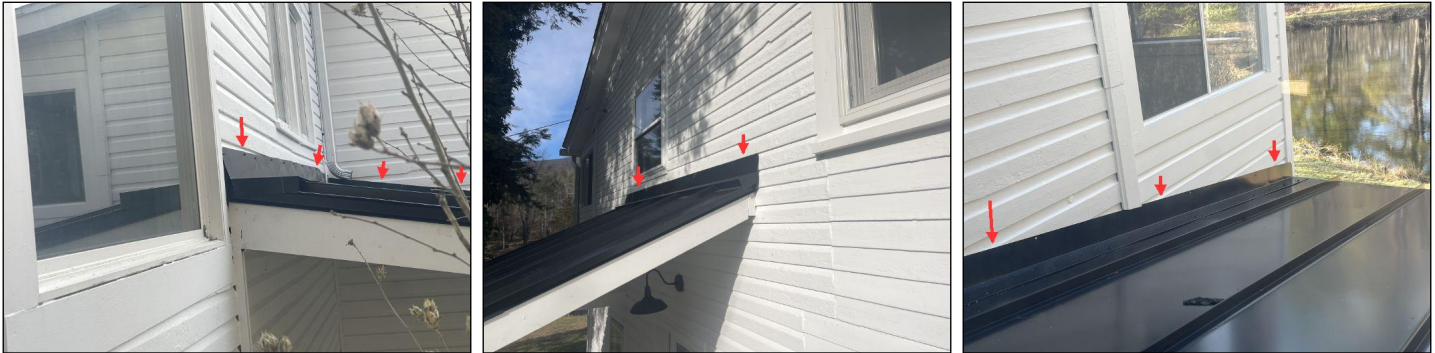
The roof to wall junctures lack proper counter flashing lapping at siding creating conducive condition to moisture intrusion and deterioration. Recommend consulting flashing specialist for review and repair of flashing to ensure water tightness.

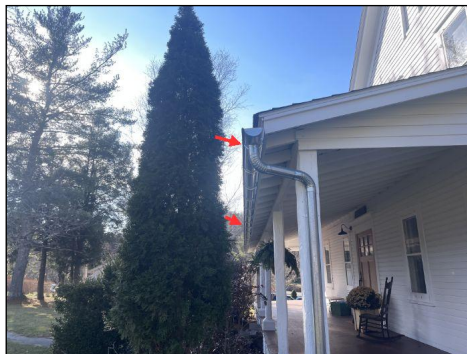
Front porch small half round gutter appears undersize for amount of roof surface drainage and should be improved to ensure water is directed away from the building.

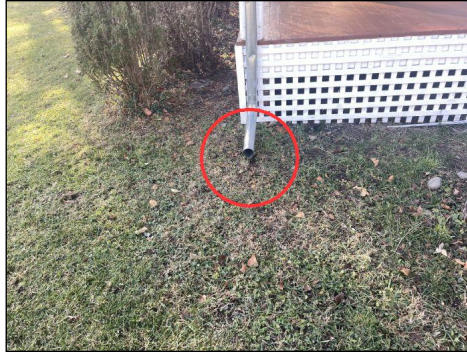
Some downspouts are draining water next to the building which is conducive to deterioration and moisture intrusion, recommend extending downspouts away from the building, typically about six feet minimum, and installing a splash block to limit erosion.

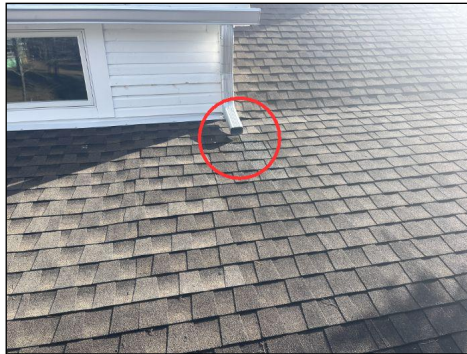
An upper gutter downspout is discharging water on the lower roof creating a conducive condition to moisture intrusion, ice damming, and deterioration, recommend extending downspout to the lower gutter or ground.

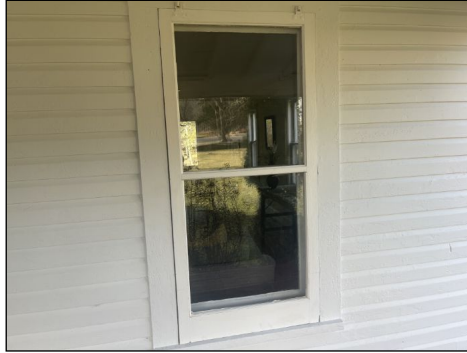
*Observations:* The windows in general are older with wear and weathering from time and use.

Single pane windows appear original to the building.

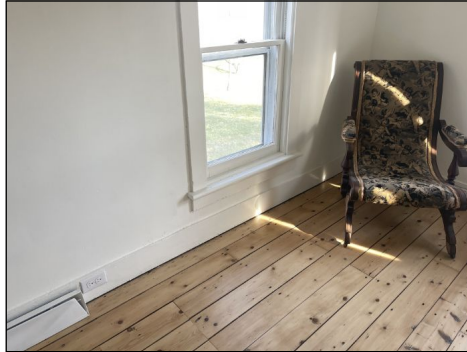
Some second floor windows that are low to the floor we can be a fall hazard, recommend installing window guards or stops in the windows to prevent opening more than 4". Consult building department for current standards.

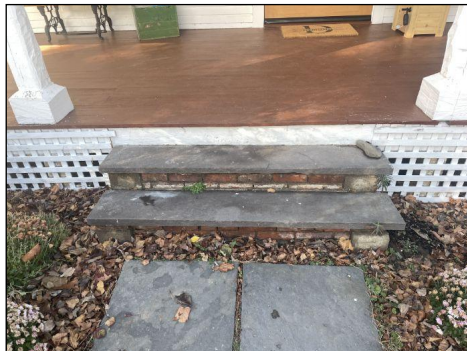
Stairway has movement and leans forward which needs repair to ensure safe usage.

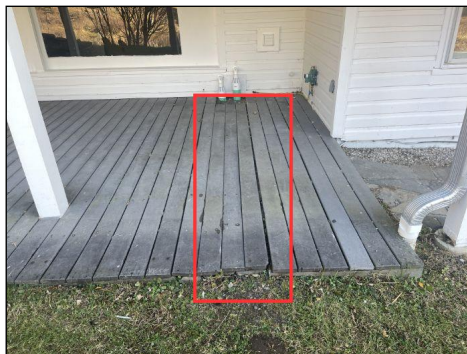
Porch floor has settlement and sloping at added subsurface sump pump drain discharge piping which needs repair to ensure integrity and safe usage.

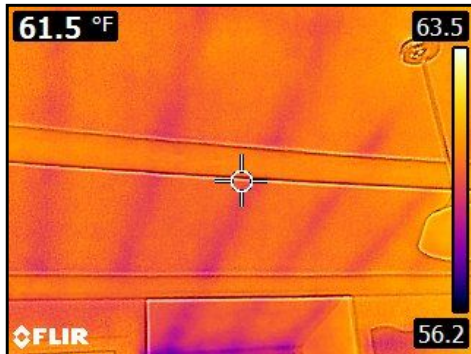
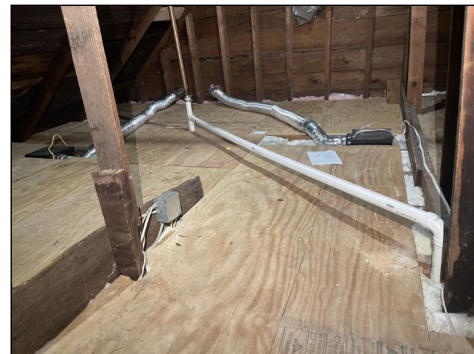
Insulation appears present with the use of thermal imaging camera.

Insulation is less than current standards, recommend insulation be added and/or replaced with coordinating ventilation for better R value and lower heating and/or cooling costs. Recommended current minimum standard is R-38.

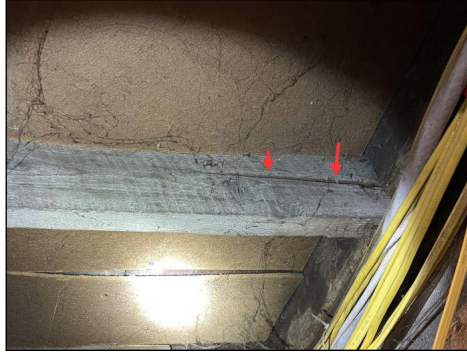
There is a cracked floor joist which needs additional support or repair to ensure integrity.

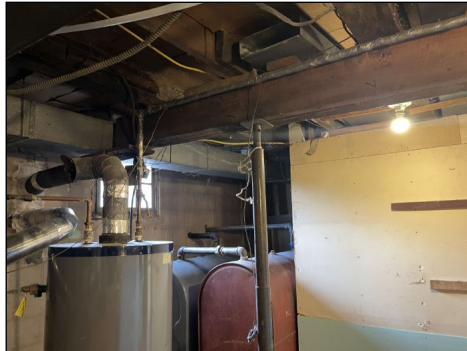
*Observations:* The floor framing has had older previous additional support, added joist, and/or repairs.

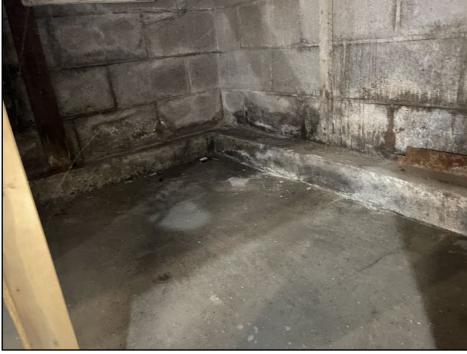
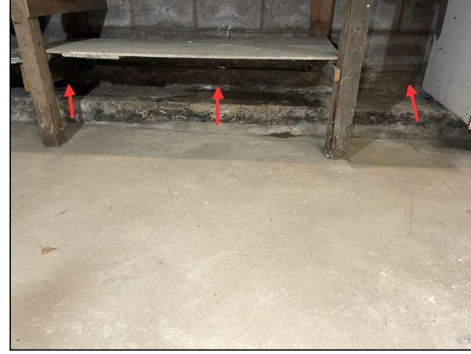
There is efflorescence and moisture staining on foundation exposed walls from periodic moisture intrusion, evaporation, and/or wicking which needs further evaluation, improvement, and/or repair by foundation drainage, grading, and sealing specialist to prevent moisture intrusion.

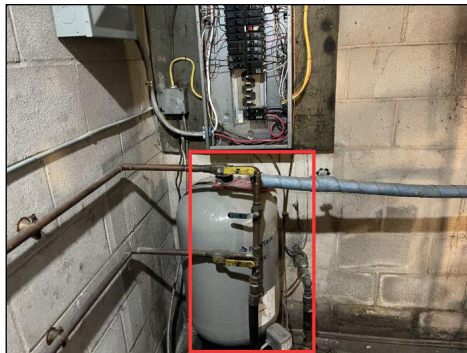
*Observations:*  
Pressure tank improperly located in front of the electrical panel which should proper clearances created. Typically, 30" x 36" in from the panel access should be maintained.

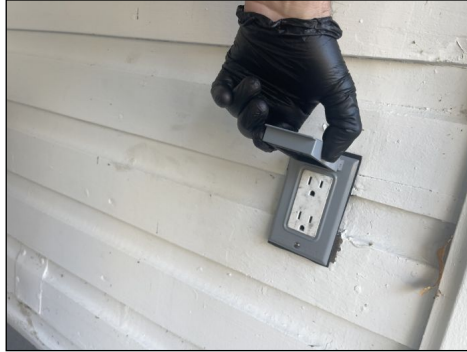
The outlets lack ground fault protection which should be upgraded or repaired by electrician to ensure safe usage.

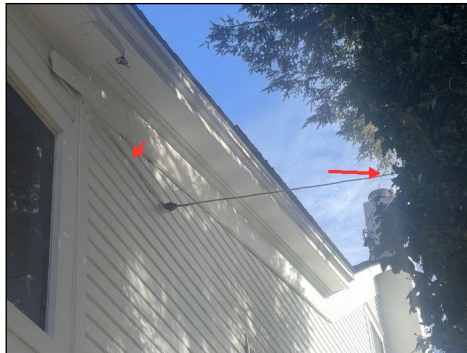
There is exposed overhead electrical serving outbuildings left side rubbing tree branches which needs review and repair by electrician to ensure safety. Typically, electrical to outbuildings is buried in conduit for current standards.

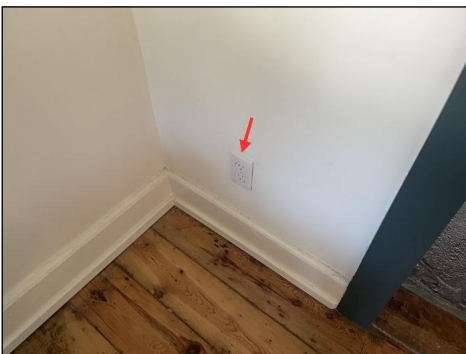
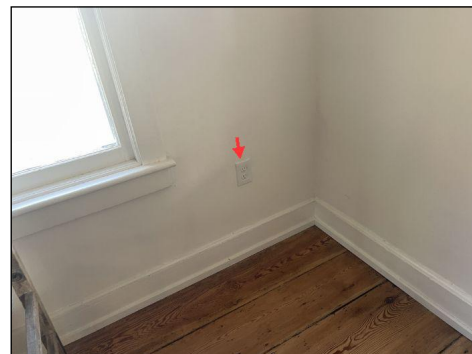
Two of the three prong outlets test lacking ground which need further evaluation and repair by electrician to ensure safety.

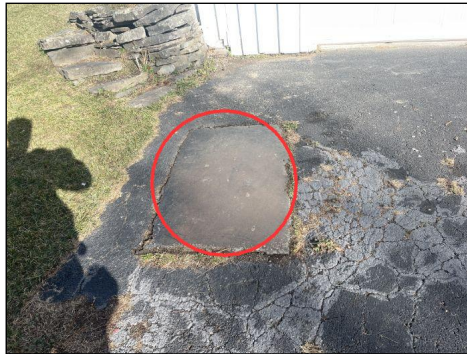
The well housing appears to be below grade which was not excavated for access, recommend having access created for further evaluation to ensure integrity and well cap.

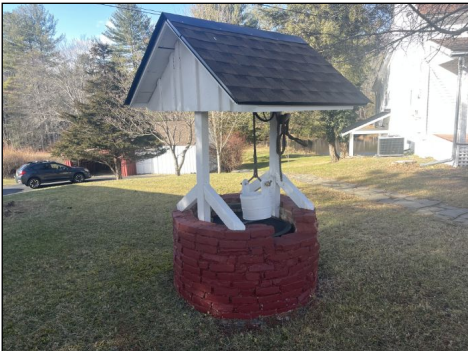
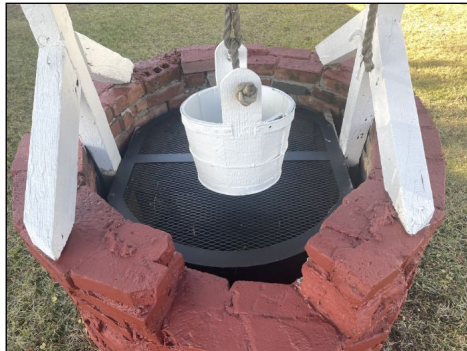
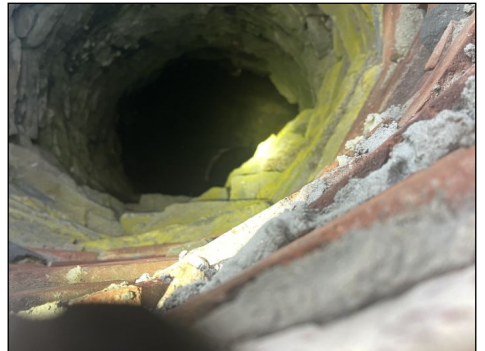
Recommend providing fastened well top lid to ensure safety or decommission and filling to ensure safety.

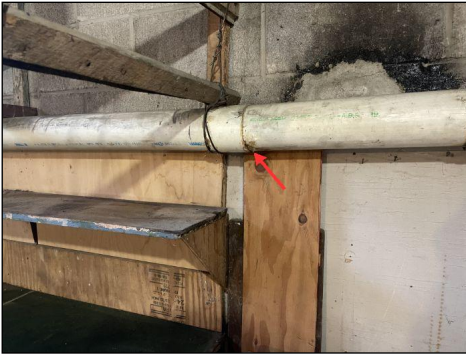
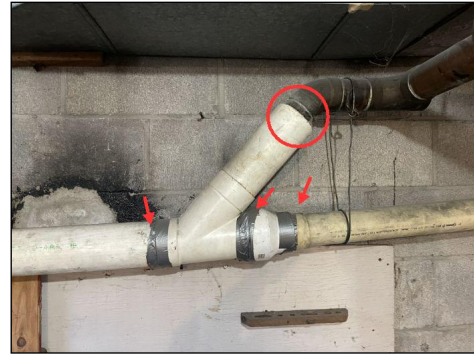
Drain piping has been unprofessionally plumbed, configured, and has open and taped connections which needs review and repair by qualified plumber to ensure water tightness and proper drainage. Connections have been taped and appear to have leaked which is evident from staining.

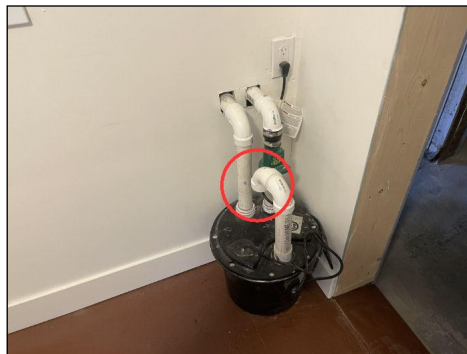
Pump up unit plumbing vent piping is incomplete which needs system review and repair by a plumber to prevent odors.

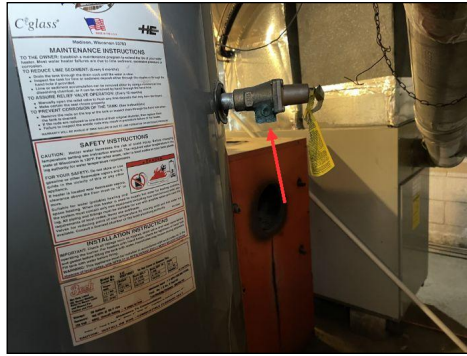
Valve lacks proper discharge piping and needs repair by plumber to ensure safety.

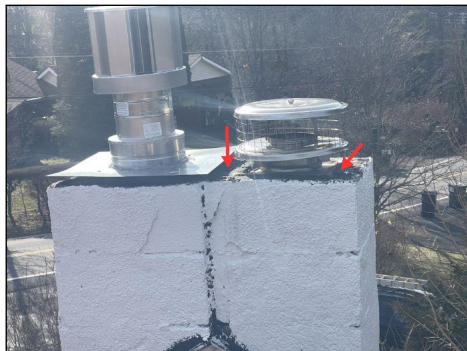
The chimney crown, which is designed to seal the top of chimney walls and shed rainwater, is deteriorated which needs repair and/or replacement to ensure integrity and water tightness.

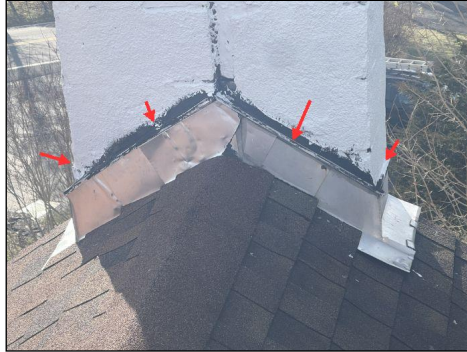
Roof to chimney counter flashing appears improperly installed and dependent on sealer at top edge which is not let into the mortar joint properly creating conducive condition to moisture intrusion, recommend further evaluation and repair by flashing specialist to ensure water tightness.

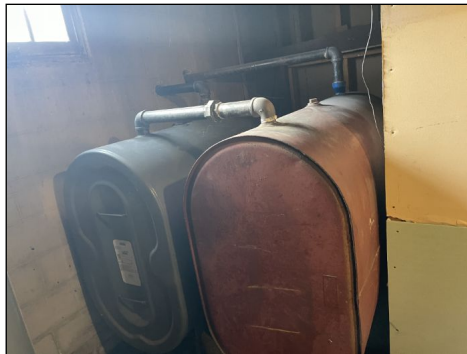
Oil tanks are in functional condition but one is older, recommend monitoring integrity of tank.

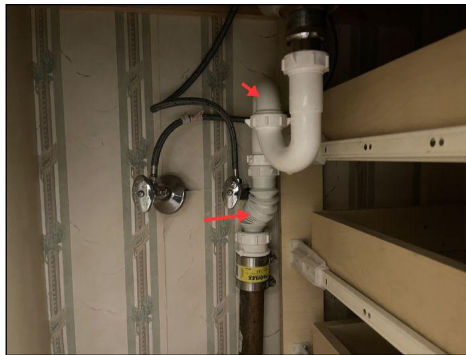
Drain line has S trap outdated design, recommend upgrading to P trap to ensure trapping of sewer gases.

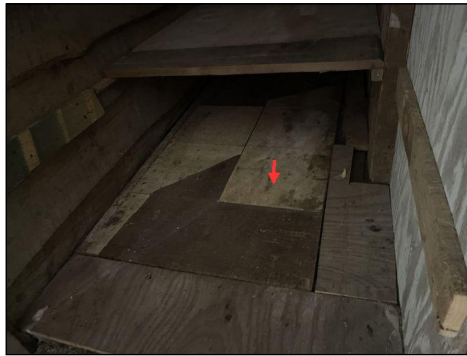
There are some floor tile remnants within the building which may contain asbestos, recommend consulting asbestos abatement specialist for evaluation and possible removal and/or encapsulation.

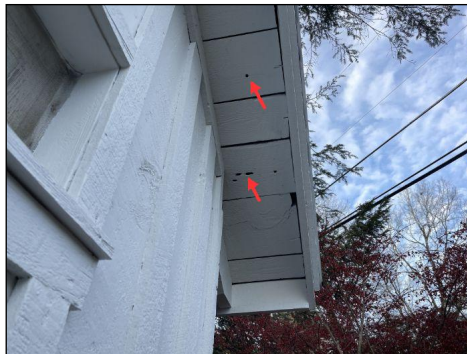
There are holes, staining, and openings in prone areas from wood boring bees which needs treatment and/or deterrent by pest control company. Recommend repairing openings and maintaining finish to deter future activity. If activity returns exterminate as needed, bees may return seasonally at spring time.

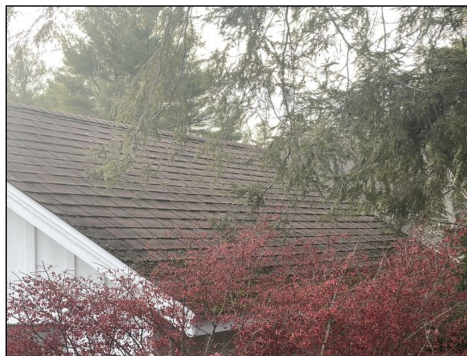
The roof has some moss and algae growth in prone areas overhanging landscaping which needs cleaning and/or prevention to ensure proper drainage and integrity.

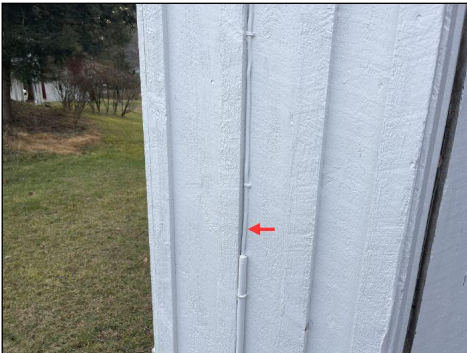
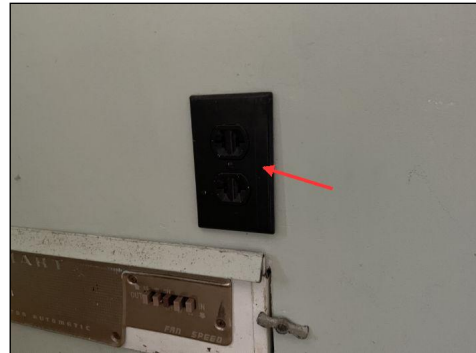
Two prong outdated outlets are present lacking grounding which need upgrading by an electrician to ensure safety.
