Independent Home Inspection LLC

Building Inspection Report

20 River View, Hudson Valley, NY 12345
Inspection prepared for: John Jones
Date of Inspection: 5/24/2018 Time: 1 PM
Age of Home: 1835 Size: 2549
Weather: 50s

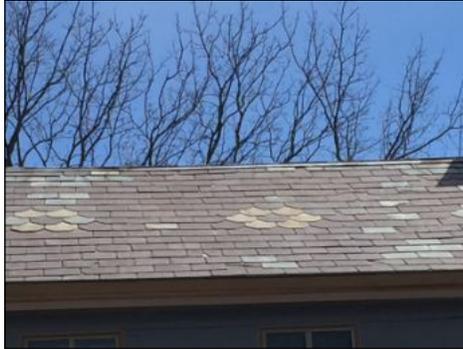
General condition of the roof covering appears functional with signs of weathering and aging appropriate to approximate age of roof.

Roofs are designed to be water resistant not water proof and require frequent maintenance on a consistent basis. Look for lifted fasteners, damage or broken shingles, and missing shingles from wind damage.

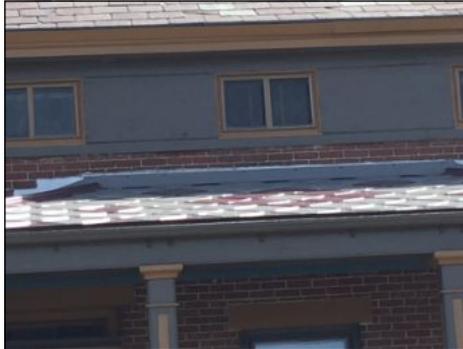
Observations: Roof surface appears functional within useful life.

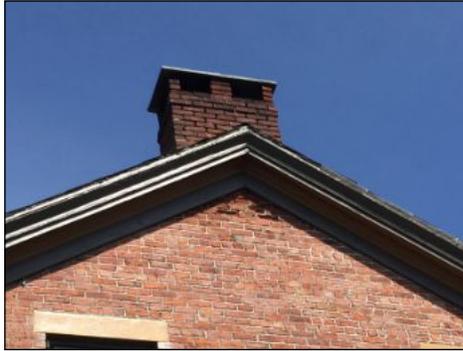
Mortar Joints

Observations: The mortar joints are washed out and deteriorated above the roof line which needs to be repaired by mason to ensure integrity and water tightness. There are some spalled bricks which need repair to ensure integrity and water tightness.

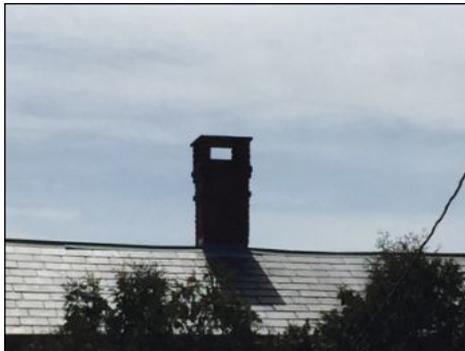
Observations: The visible portions of the chimney appears functional with some weathering.

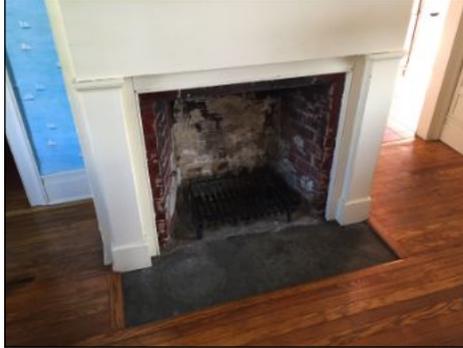
Observations: Wood burning fireplace is present.

Recommend further evaluation before use by fireplace specialist to ensure safe usage.

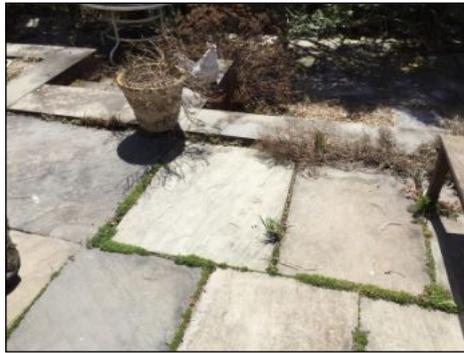
Settlement

Observations: Sections of the surface has some minor settlement creating potential trip hazards which needs subbase repairs to ensure safe usage.

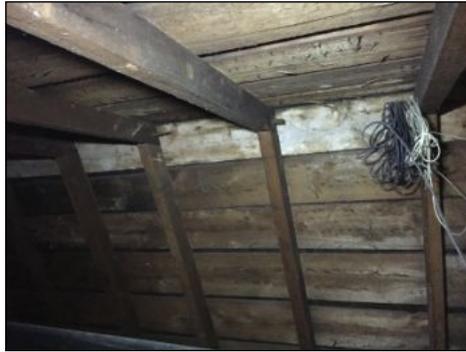
Observations: The integrity of the visible portions of the roof framing are in functional condition.

Roof rafters appear undersized and or over spaced for the span by current standards which is typical for older building and should be monitored.

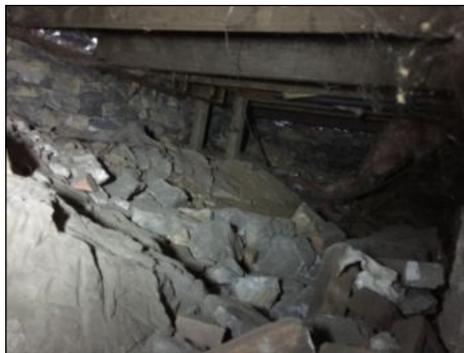
Observations: Recommend installing vapor barrier or crawl space liner over soil of crawlspace to prevent soil moisture intrusion.

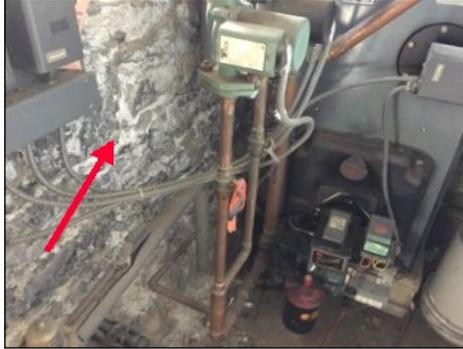
Foundation Moisture Intrusion

Observations: There is efflorescence and moisture staining on foundation exposed walls from periodic moisture intrusion, evaporation, and or wicking which needs further evaluation and repair by foundation sealer specialist to prevent moisture intrusion.

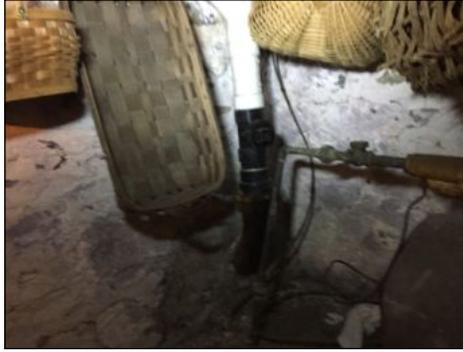
Observations: Clean out port is present.

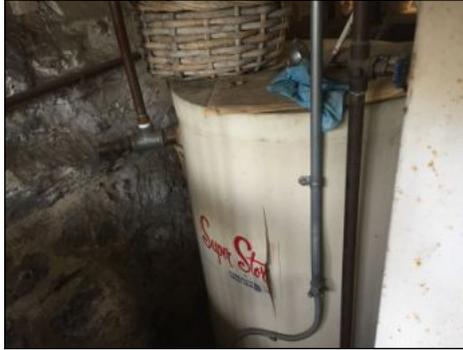
Observations: Water heater is creating hot water but is older and should not be expected to last a long period of time. Plans for replacement should be made to ensure proper operation.

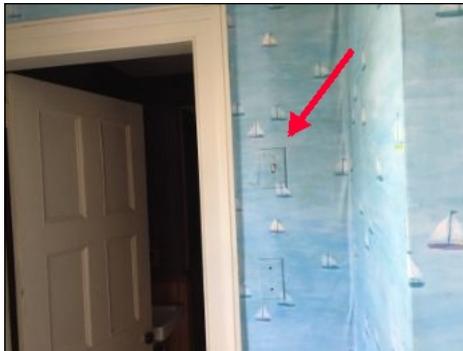
Observations: Switch is present

Switch lacks proper labeled switch plate cover which needs repair to prevent accidental deactivation of the heating system.

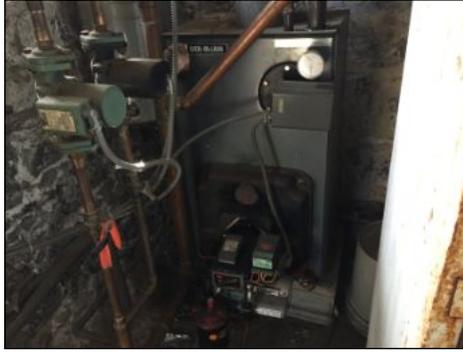
Observations: Heating system was tested by activating with the use of the thermostat which activated at time of inspection.

System is older but functioning. These type of unit can function for long periods of time with replacement parts but you may benefit from replacing unit due to increased reliability and efficiency. System should not be expected to last a long period of time and plans for replacement should be made.

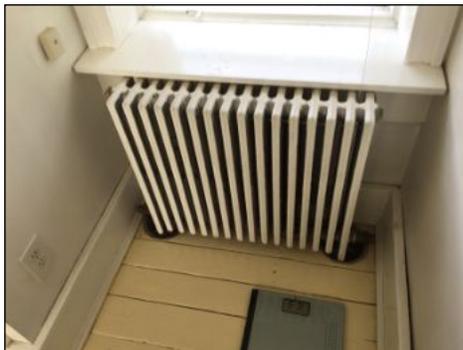
Observations: **Areas lack central heating source which should be added to ensure even heating.**

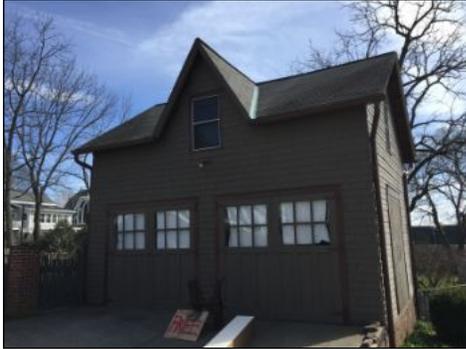
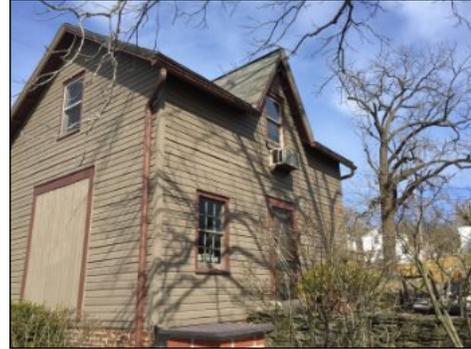
Detached Garage

Observations: Boat storage building with office space above

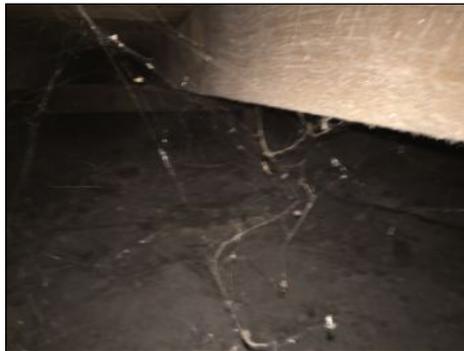
Garage Floor

Observations: Wood framed, appears not designed to support vehicles.
Recommend vapor barrier over crawlspace soil.

Crawlspace area lacks access which should be created for further evaluation.

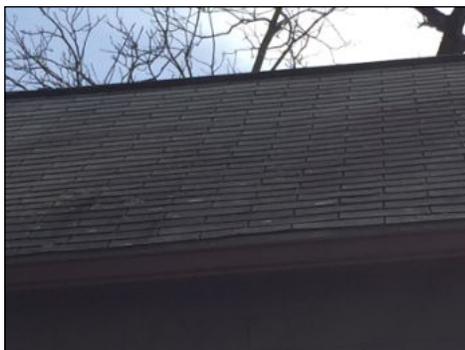
Observations: The roof surface has loss of aggregate and brittleness noted which indicates the surface is wearing. This means that the roof should be inspected more frequently and monitored for leaks as the roof will need replacing in the near future.
