# Independent Home Inspection LLC

## Inspection Report

123 Main Street, Anytown, NY 12540

Date of Inspection: 1/1/2025 Time: 12:30 PM

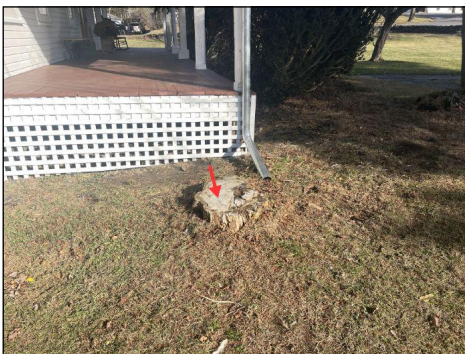
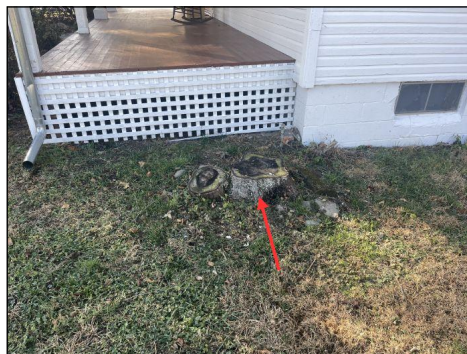
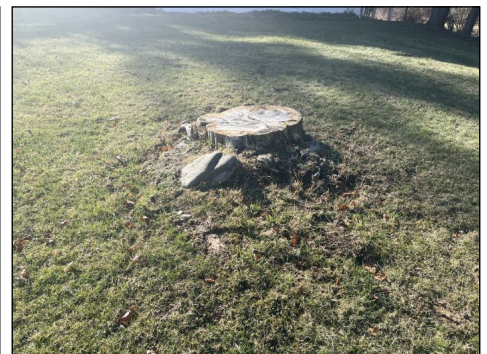
There are some tree stumps present which are conducive to wood destroying insects that should be removed or ground.

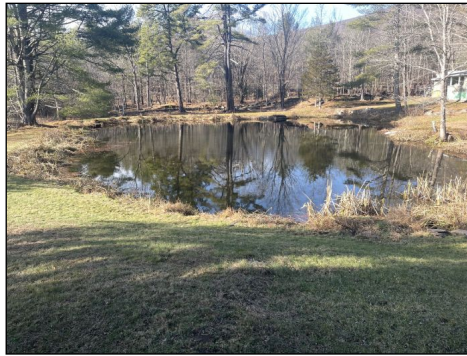
There is a pond and stream crossing the property which has the potential to create erosion and ponding water which should be monitored and maintained. Consult owner and municipality for liability and limitations.

Consult owner and municipality for liability and limitations.

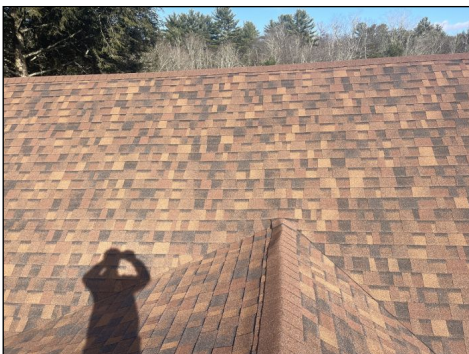
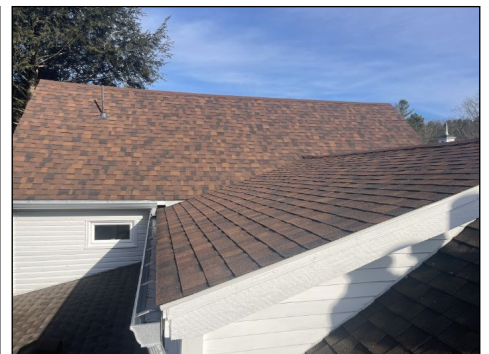
*Observations:* The roof surface is in functional condition.

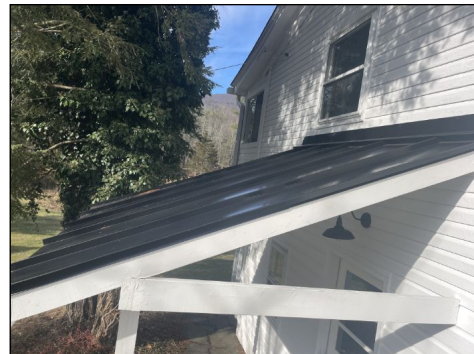
*Observations:* The roof surface is in functional condition.

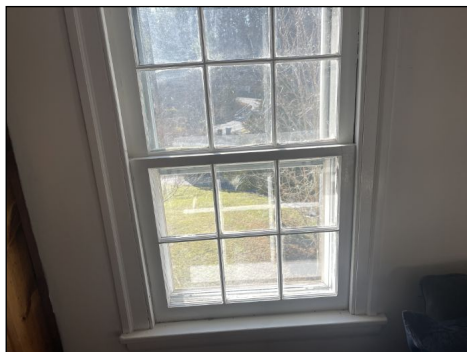
Several windows lack locks or have been removed which need installation to ensure weather tightness and security.

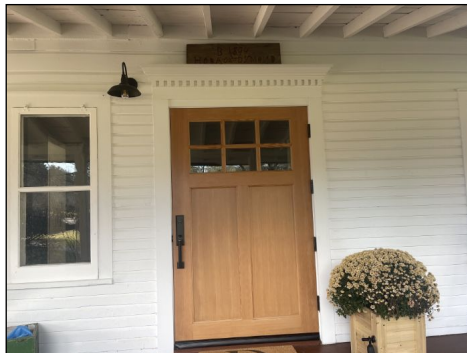
Area lacks door bell.

Door is not fully weather sealed and should be improved for energy efficiency.

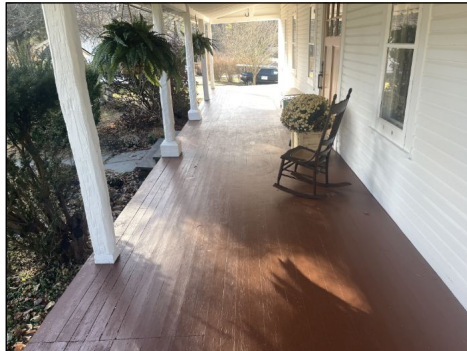
*Observations:* The porch is functional but older with weathering.

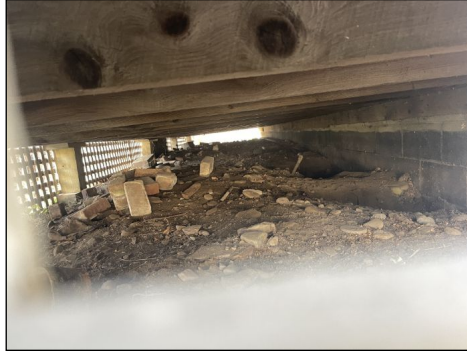
*Observations:* The integrity of the visible sections of floor framing appear functional.

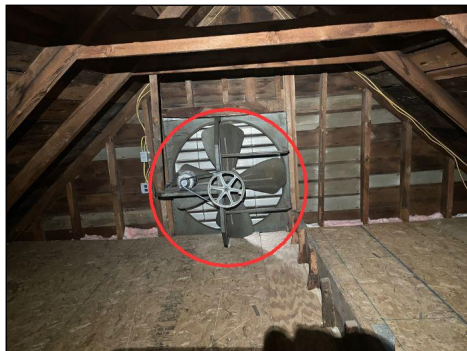
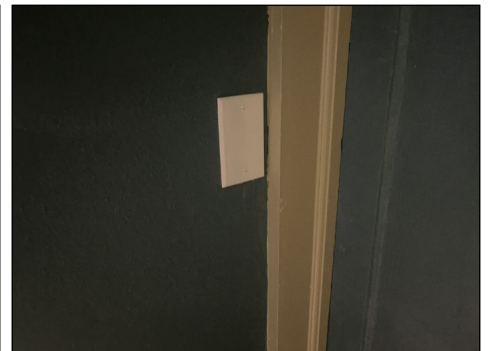
*Observations:* Whole house exhaust fan is present which can create a conducive condition to back drafting of flue when in use that requires multiple windows open when in use.

Fan does not activate and switch is removed and covered which needs decommissioning and/or removal.

Fan lacks interior and intake louver requiring attic door to be open when fan is in use which you may wish to improve or decommission.

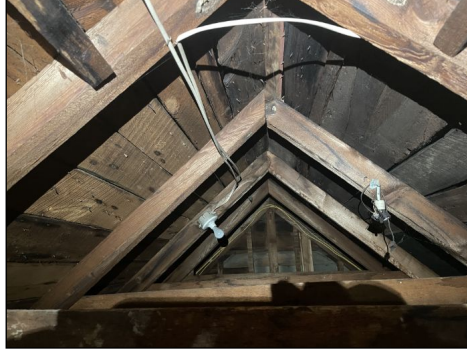
*Observations:* The integrity of the visible portions of the structure are in functional condition.

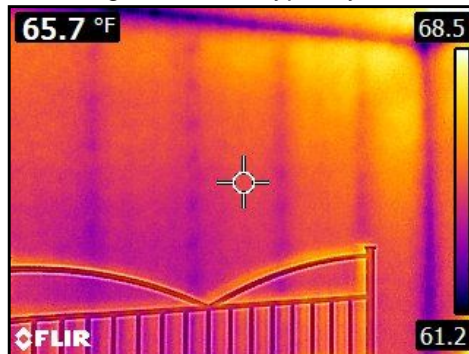
*Observations:* Insulation appears present with the use of thermal imaging camera in most areas.

Not visible but is 2"x4" framing typically indicating 2.5" to 3.5" typically.

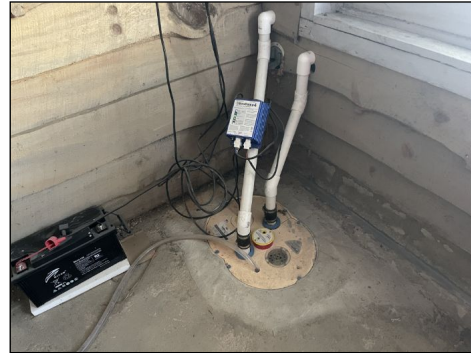
Basement appears dependent on sump pump at times to prevent ponding water which should be monitored and maintained by pump specialist to ensure proper operation.

Recommend back up power to ensure sump pump operation during power outages to prevent potential ponding water within the building.

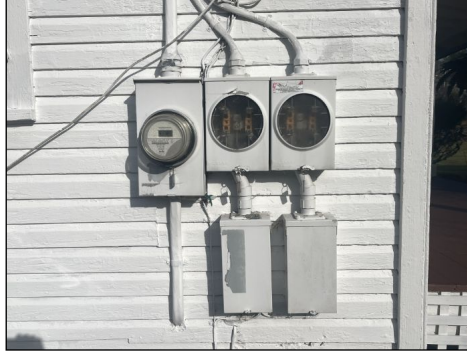
*Observations:* Meter pan is functional condition.

Decommissioned previous apartment meter pans are present.

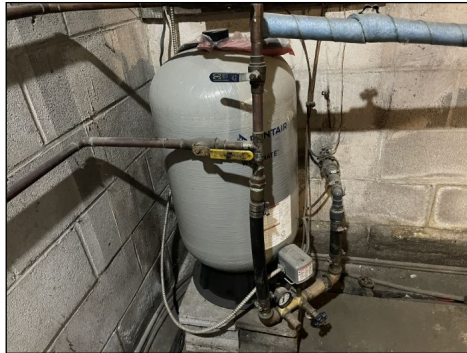
Pressure tank is in functional condition.

Recommend insulating pressure tank to prevent condensation.

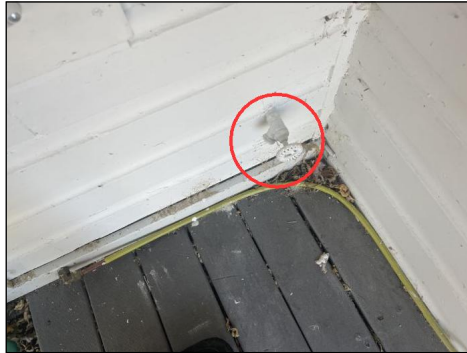
Spigot is older and not activated and appears weatherized which should be activated to ensure proper operation.

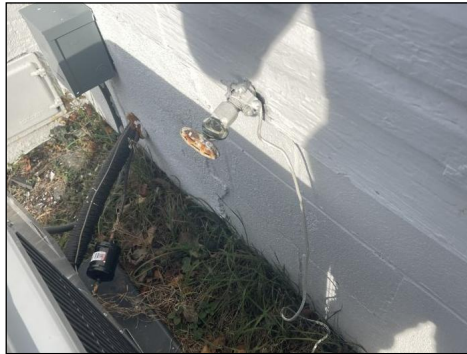
*Location:* Left side of the building

Spigot is not activated and appears weatherized which should be activated and tested to ensure proper operation.

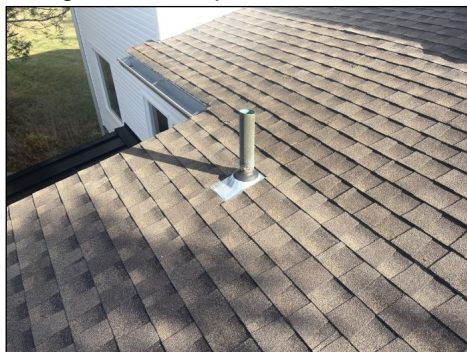
*Observations:* Roof terminated plumbing drainage vents are present.

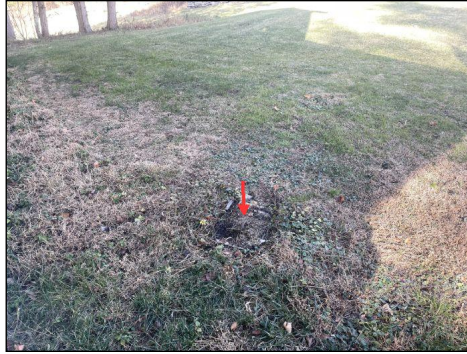
*Observations:* System and its components are buried limiting visual access, type, and locations of systems. System would need access created for further evaluation.

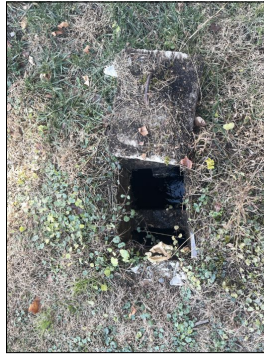
*Location:* System tank appears to be at right side of the building.

*Observations:* Visible riser access cover is present.

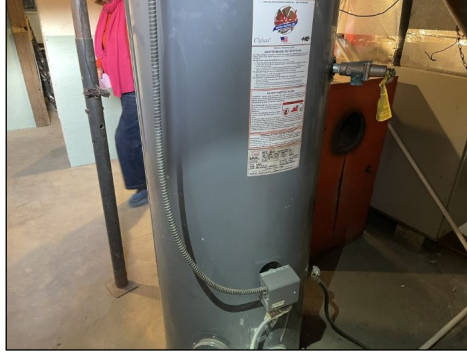
**Observations:** Water heater is activated and creating hot water.

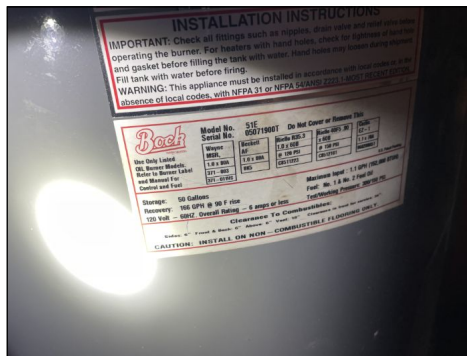
Water heater is older and in accordance with the units designed lifespan should not be expected to last a long period of time and plans for updating should be made.

Recommend annual inspection, maintenance, and/or draining of sediment by plumber.

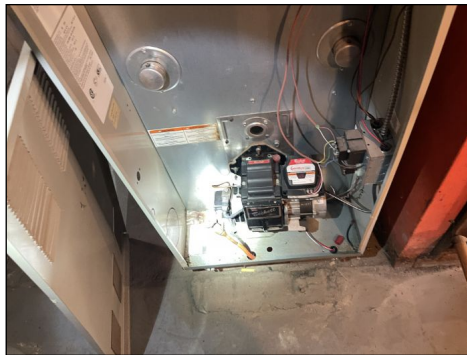
**System appears due for its annual maintenance.**

*Maintenance Observations:* Maintain yearly inspections and unit cleaning by heating specialist. Some components of the system such as controls typically do not last as long as the system and may need repairs in the future to keep the system functional. Monitor your system particularly after periods of non use.

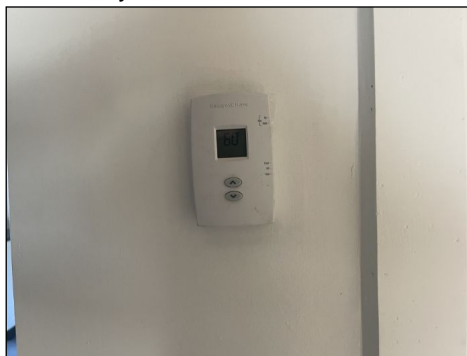
*Observations:* Thermostat is present and activated system.

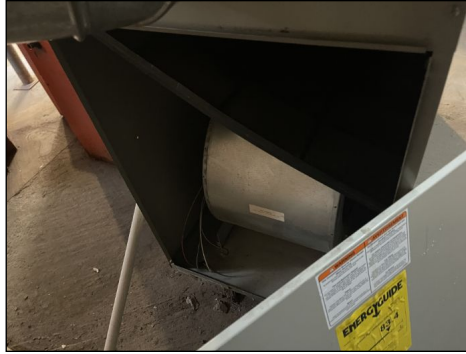
**The system serves basement and two floors which lacks zoning per floor which you may wish to improve or upgrade by HVAC specialists to ensure even conditioning per floor.**

*Recommend changing air filter.*

*Recommend changing air filter every 30 to 90 days during peak usage.*

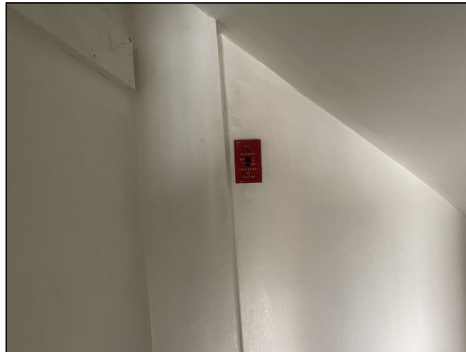
*Observations:* Switches are present.

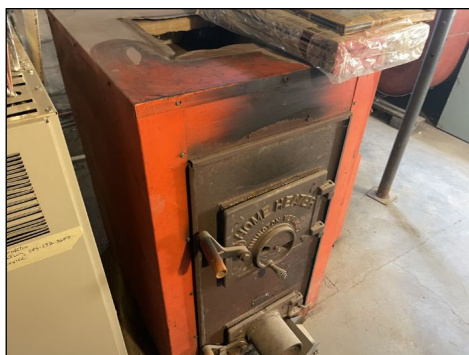
*Outdated abandon disconnected unit is present in the basement which needs removal.*

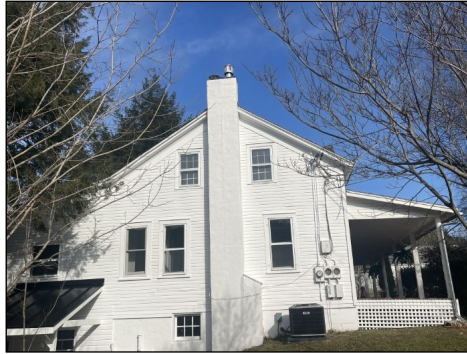
*Observations:* The visible portions of the chimney integrity appears functional with some weathering.

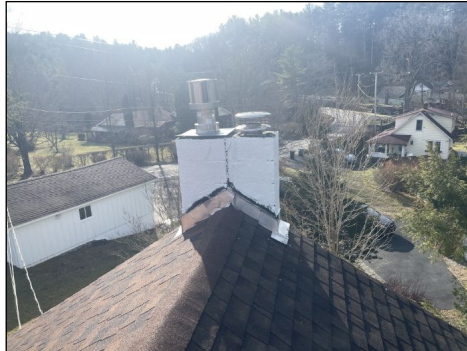
*Observations:* Weather caps are present.

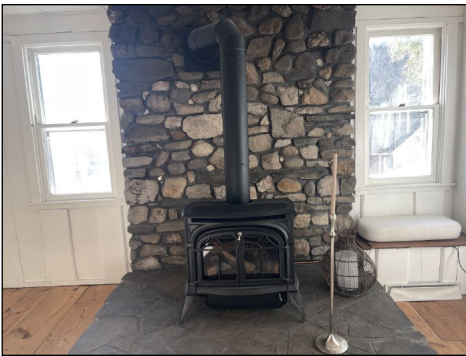
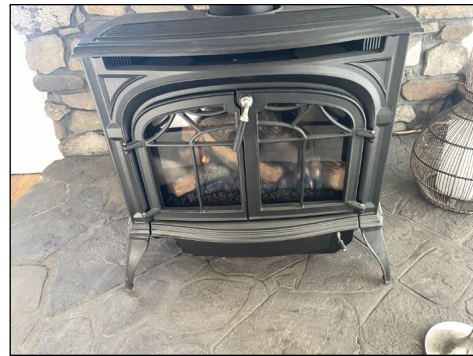
*Observations:* Gas fireplace is present which activated with the use of controls during inspection.

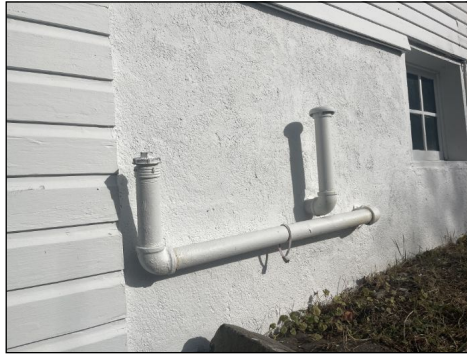
*Observations:* Fill and vent pipe ports are present.

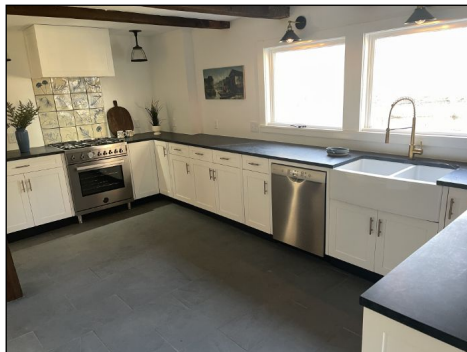
*Observations:* Cabinets are in functional condition.

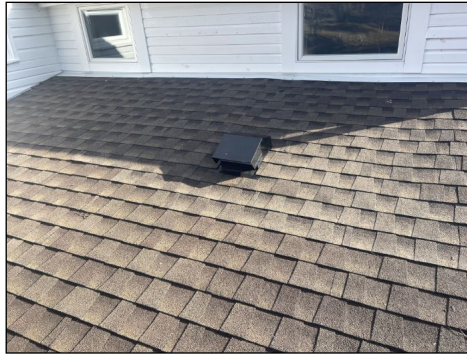
*Observations:* The exhaust fan is functional and vents to the exterior.

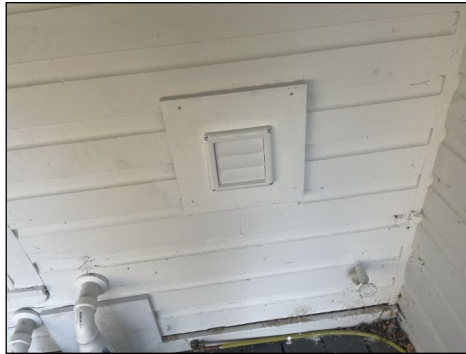
*Observations:* Vent hood is present.

*Recommend periodic cleaning of dryer vent ducting and vent hood.*

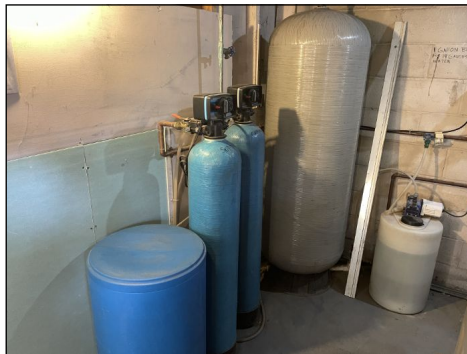
*Observations:* Water conditioning/filtration equipment are present.

**Recommend consulting a water filtration and conditioning system specialist for monitoring, maintaining, and/or servicing of existing equipment to ensure water quality.**

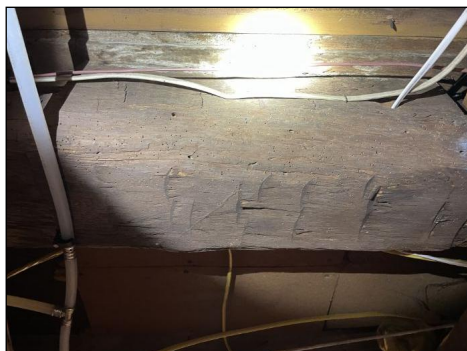
There are older exit holes in the framing timbers from previous powder post beetle activity which should be monitored for activity. Recommend consulting pest control company for monitoring and deterrent methods.

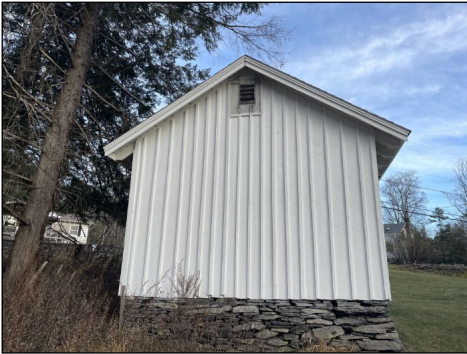
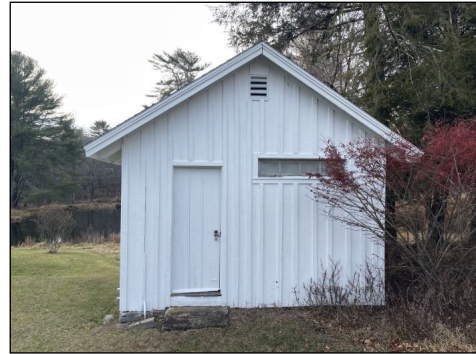
*Observations:* Large shed
